# Watershed Restoration Technical Bulletin

## Streamline

Vol. 4 No. 2

## Analyzing the Effectiveness of Common Road Construction and Deactivation Techniques

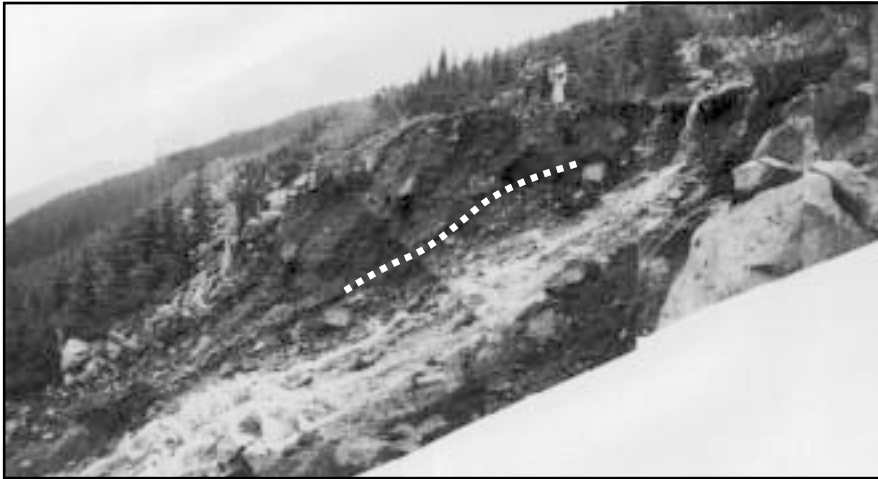
Figure 1. A southern coastal mainland road fill failure showing the workers for scale, the high cut tree stump supporting residual sidecast road fill, and the almost planar nature of the failure surface. The dashed white line highlights a layer of black, decomposed organics within the sidewall of the slide.

This study uses the finite planar slope stability model to analyze the road fill failure shown in Figure 1. The failure occurred near Pemberton B.C. within the Pacific Range of the Coastal Mountains. The model is an acceptable approximation of the local terrain, manner of road construction, and mechanics of the failure. For the failure in question, the model predicts:

The model is especially well suited to the slope failure illustrated in Figure 1. The geometry of the site, woody debris in the fill slope, well defined headwall of the slide and shallow soil depth to the smooth, massive, underlying bedrock, make this slide an almost ideal example of a planar slope failure.

The site illustrated in Figures 1 and 3 was surveyed within 72 hours of failure. Figure 4 is a best estimate, cross-sectional reconstruction of the road fill moments before it slid from the hillslope. The failure was triggered by an abundance of surface water entering open tension cracks along the shoulder of the approximately 20-year-old, abandoned roadway. The road was built by sidecasting on an open, steep, uniform slope composed of a thin veneer of weathered, silty sand, non plastic (~<10% silt and clay) till upon massive, smooth, granitic bedrock. The weathered till and top of the bedrock were laced with thin, discontinuous, seams of decomposed organics.

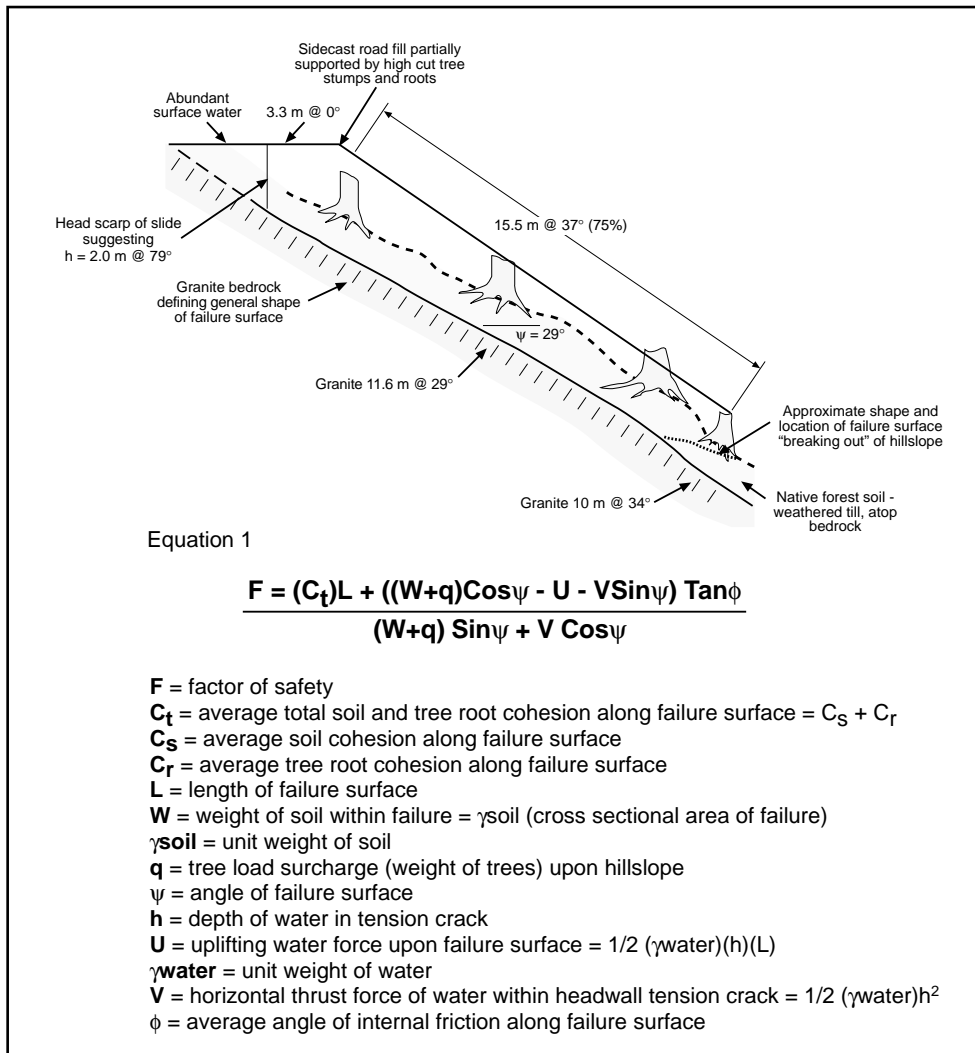
Figure 2. The Finite Planar Slope Stability Model.

This model, adapted for use upon a typical sidecast road fill, is illustrated in Figure 2, equation 1; at the base of Figure 2 is the equation for calculating the factor of safety for a typical sidecast road fill. The model requires the prospective failure surface to be a straight line, but readily accommodates convoluted ground (fill slope) surfaces and tension cracking. The model is a useful approximation of road fill failures because:

- It is widely observed that road fill failures approximate planar failures (Gray and Leiser, 1982. pp 33-34).
- The core equations for numerical modeling of finite planar slope failures are well established (Hoek and Bray, 1981. pp 7.1-7.3) and can be readily modified to incorporate tree load surcharging, tree root cohesion and water pressures, which the US Forest Service (Hammond et al, 1992. pp 53-74 and 82-86) suggests are appropriate for coastal BC (Figure 2).

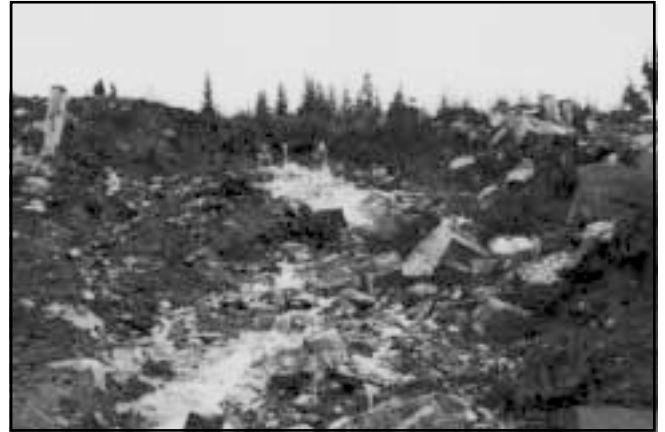
Figure 3. Photograph of the slide's initiation zone. Note the planar nature of failure surface, high cut tree stumps supporting road fill and abundance of water flowing over the headwall of the slide.

From the abundance of water at the site (see Figures 1 and 3) it is possible to infer that the tension cracks at the headwall of the slide were completely full of water at the moment of failure. Using iterative calculations, the average angle of internal friction and average total cohesion along the failure surface at the moment of failure can be estimated. The text portion of Figure 4 summarizes the slope stability input parameters derived from iterative back analysis of the failure, engineering judgement, and experience.

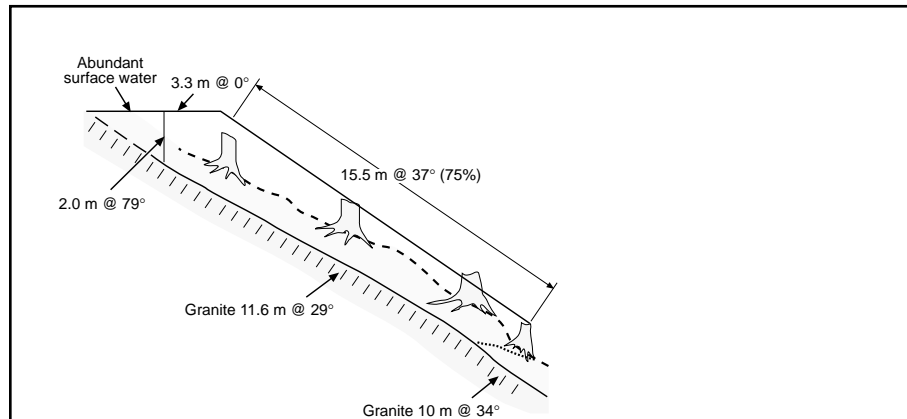
### Road Fill Failed @ 20 yrs post harvest

- $\phi = 32^\circ$  on failure surface by back analysis
- $C_t = 4.4$  kPa on failure surface by back analysis
- $L = 17.7$  m length of failure surface by geometry
- $\gamma_{\text{soil dry}} = 16.0$  kN/m<sup>3</sup> by Lisa figure 5.11
- $\gamma_{\text{soil wet}} = 20.0$  kN/m<sup>3</sup> by Lisa figure 5.11
- $\psi = 29^\circ$  angle of failure surface by geometry
- $h = 2.0$  m by field measurement
- $V = 1/2 \gamma_{\text{water}} h^2 = 1/2(9.8 \text{ kN/m}^3)(2.0 \text{ m})^2 = 19.6$  kN/m
- $U = 1/2 \gamma_{\text{water}} hL = 1/2(9.8 \text{ kN/m}^3)(2.0 \text{ m})(17.7 \text{ m}) = 173$  kN/m
- $A =$  cross sectional area of failure =  $44 \text{ m}^2$
- $W_{\text{wet}} = A(\gamma_{\text{soil wet}}) = 44 \text{ m}^2(20.0 \text{ kN/m}^3) = 880$  kN/m
- $W_{\text{dry}} = A(\gamma_{\text{soil dry}}) = 44 \text{ m}^2(16.0 \text{ kN/m}^3) = 704$  kN/m
- $q = 0$  kPa

Figure 4. Back analysis of the failure illustrated in the two photographs.

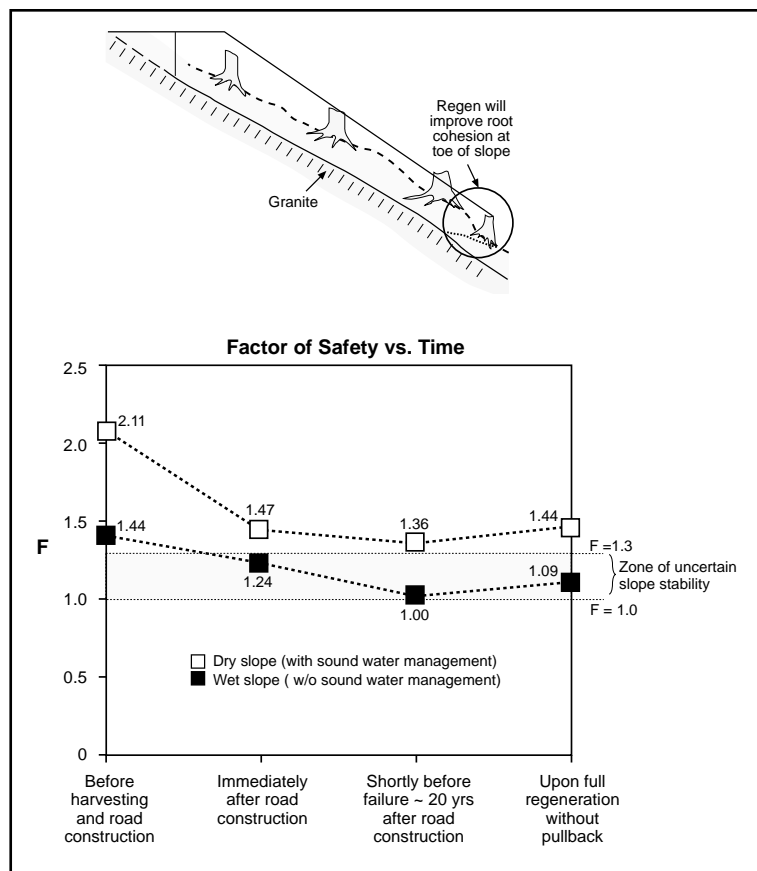
Figure 5. The slope stability “life cycle” of the road fill.

Figure 5 is a plot of the slope’s factor of safety versus various slope treatments which loosely correspond to the age of the sidecast road fill. Along the y axis of the graph is the factor of safety ( $F$ ); plotted on the x axis is slope treatment. The horizontal lines at  $F = 1.0$  and  $F = 1.3$  illustrate the range of uncertain slope stability due to foreseeable errors in the back analysis of slope stability input parameters and site geometry. Open

squares on the plot are the calculated dry (completely unsaturated) factor of safety for the slope treatment described along the bottom of the graph. Black squares are the calculated wet (fully saturated) factor of safety ( $F$ ) for each slope treatment. The dashed lines between open and black squares illustrate the relative change in  $F$  between the various slope treatments. The analysis of the fully regenerated road fill is speculative due to the potential for long term erosion of sidecast road fill and decomposition of woody debris in the fill slope. The key conclusions from Figure 5 are:

- The road fill was quite stable when built; however, stability of the road fill decreased with decay of the supporting tree roots. The abundance of water flowing into open tension cracks eventually floated the road fill from the hillslope.
- The failure would not have occurred had there been sound water control measures at the site.
- If the road fill had not failed it would have remained potentially unstable, in severe groundwater/runoff conditions, into the indefinite future. Even fully reforested, it is possible that some future storm or snowmelt event could have induced failure of the road fill. Because  $(\phi) > (\psi)$ , the weight of the regenerative forest on the road fill would have modestly improved the stability of the road fill. However, reforestation would not have significantly

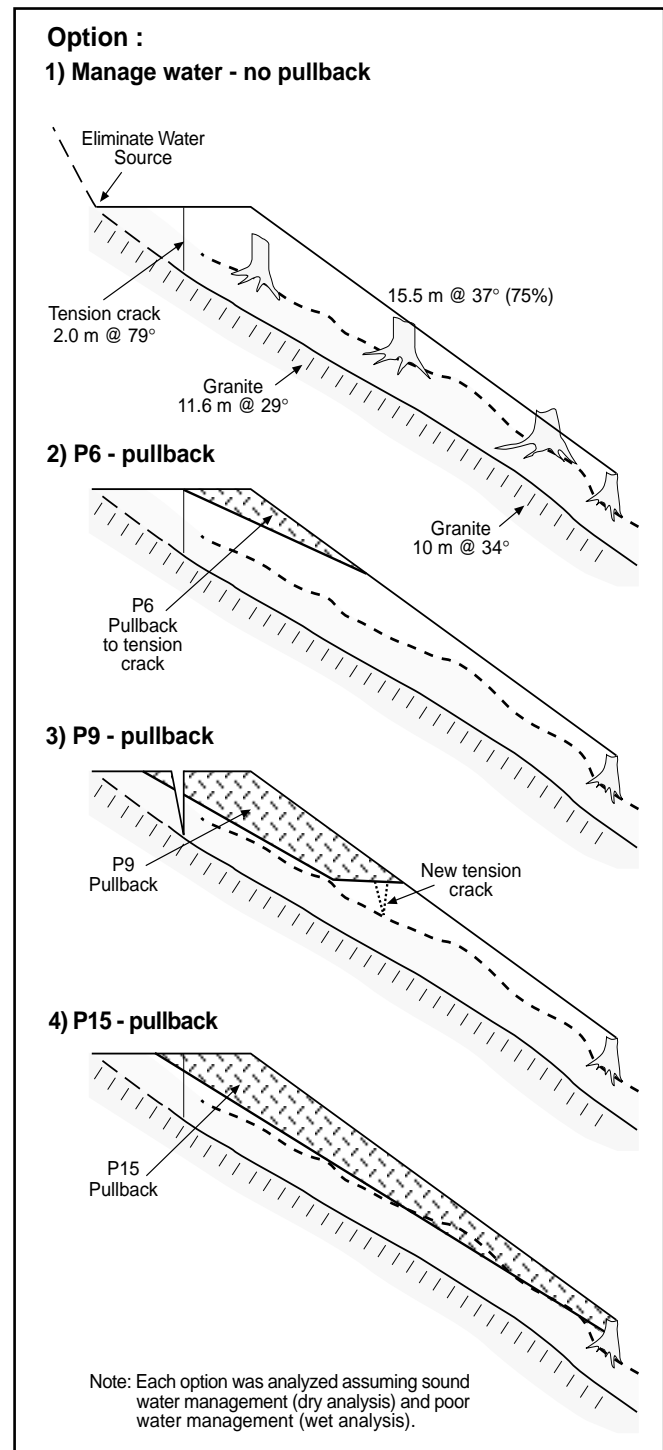
Figure 6. Stabilization Options - the most probable deactivation treatments.

Figure 6 illustrates the four most practical stabilization options for the site. The slope's factor of safety (**F**) response to each of the stabilization options was calculated by making appropriate modifications to the weight (cross-sectional area) of the prospective road fill failure and water pressures in the fill slope.

- Water control accounts for most of the slope stability improvement in all of the analyzed stabilization options.
- P6 and P9 pullback decrease the stability of the road fill in fully saturated (wet) conditions. P6 and P9 decrease the stability of the road fill by reducing the weight of the potential failure mass; since  $(\phi) > (\psi)$  removing weight on the potential failure surface decreases slope stability. Therefore, directing surface water on a partially pulled back, previously dry sidecast road fill is a calculated risk. As cross ditches are the leading cause of "road deactivation related landslides (Advanced Road Deactivation Course Manual, 1997. p 11)," there is an excellent correlation between the conclusions derived from slope stability analysis and field observations of actual road deactivation works.

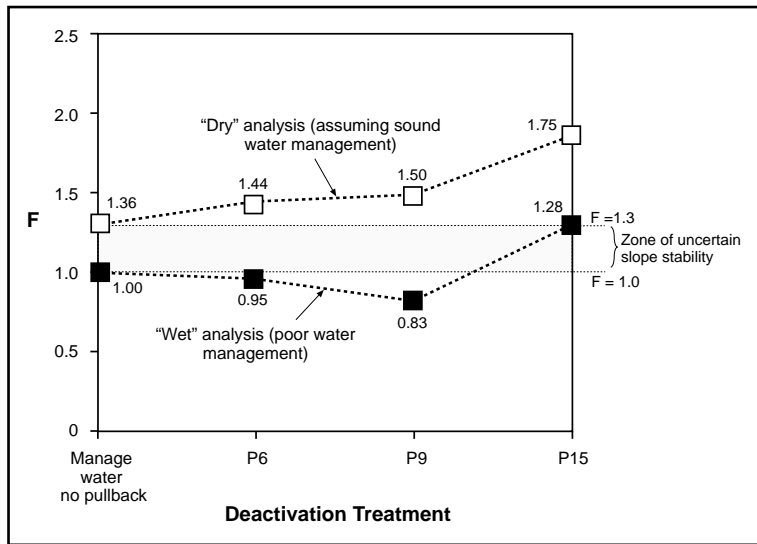
Figure 7. The Road Fill's Immediate Factor of Safety Response to Deactivation.

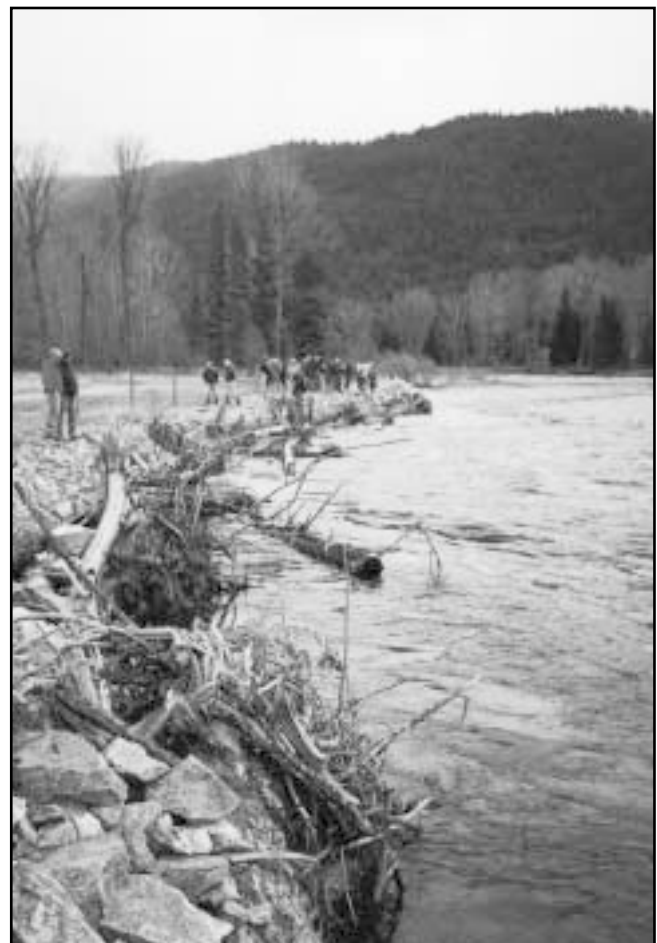
Participants at the BC - US Technical Exchange visiting a recent rip-rap and LWD treatment of an eroding bank at the West Kettle River near Beaverdell. (Work completed by Attrill Woodworking Services.)

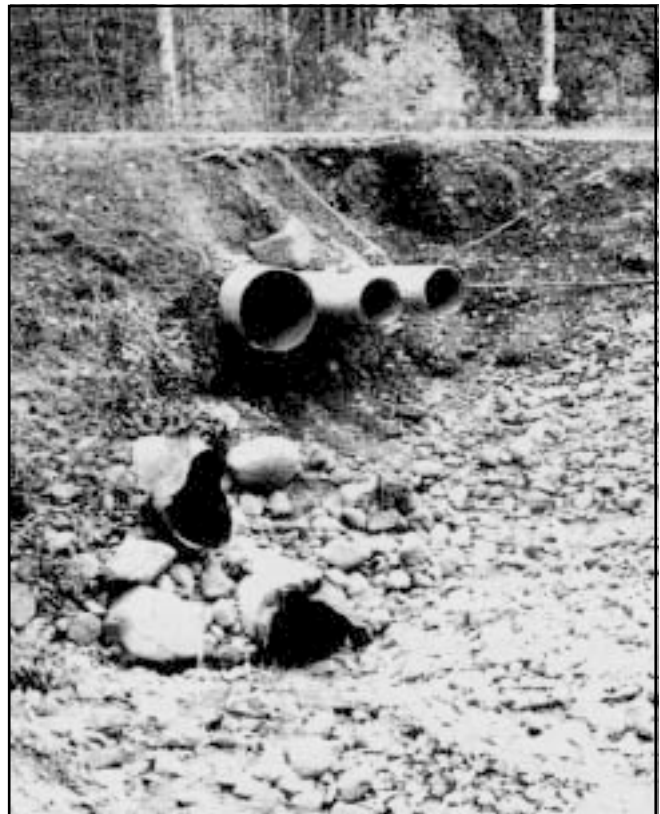
An example of fish barriers caused by road construction: Central and Northern Interior Fish Access by Michael Parker (see page 9A).

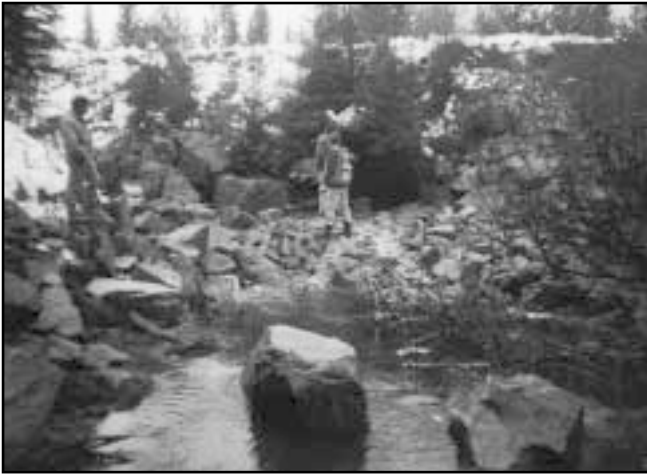
Figure 5. Rock riffle from culvert outlet that formerly had a 0.54 m drop.

Over the long term, the weir riffle structures may be less stable and the relative elevations will drop slightly. However, the large angular material prescribed and used in construction is expected to keep the structures functional.

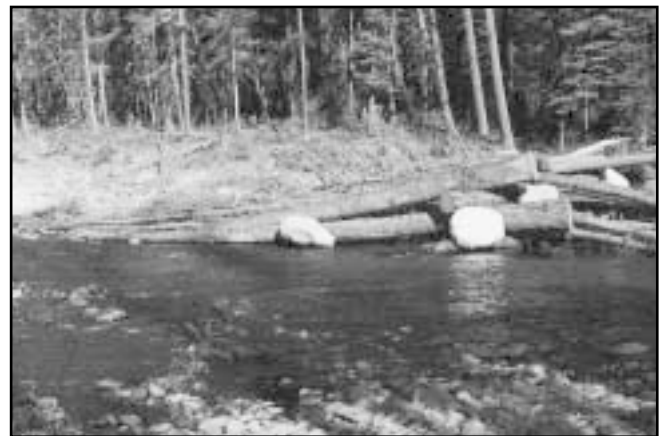
Figure 1. Debris groin at the West Kettle River, ballasted to hold ramp-logs against the channel bed.

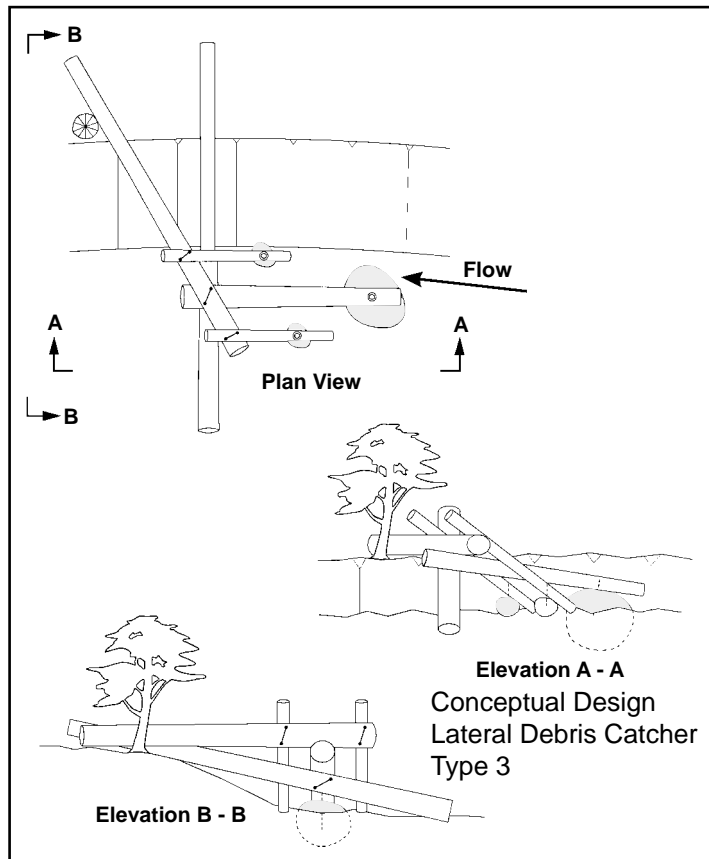
Figure 4. Debris groin type 3 for use at a site where a large boulder is unavailable for the main support log, but are available for ramp logs.

Figures 2, 3 and 4 show the design features of debris groins. Specifications for materials will vary with stream power, as indicated by channel width and gradient. The width of the debris groin should be adjusted according to the amount the channel has been widened. At Narrowlake Creek, where the stream was widened by 2-3 times, the debris groins were 6 m wide. Structures installed for demonstration in the more constricted channel at Keogh River were only 3 m wide. Height is another important design feature. Debris groins should extend just above bankfull flood levels to prevent trapped woody debris from being washed away at a peak event, as occurred at the Coquitlam River (Figure 5). Some variations in design will also be needed to take advantage of large instream boulders for attachment, or to provide an elevated support for the structural members of the debris groins if the site is along a steep bank. Use of opposing rootwads to provide in-channel height is an option that also creates prime rearing habitat

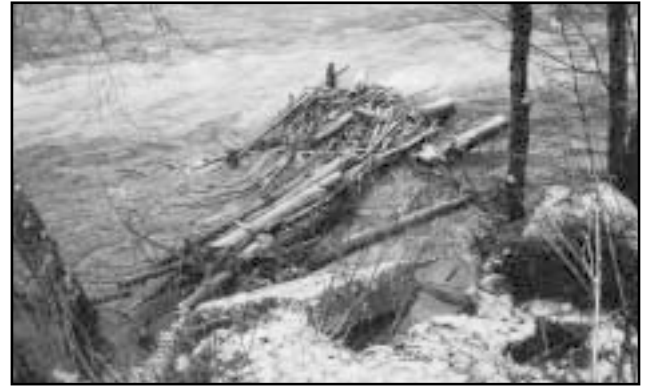
Figure 5. Debris groin at Coquitlam River in winter, 1999. The height of the groin should be just above floodplain height to prevent debris washout.

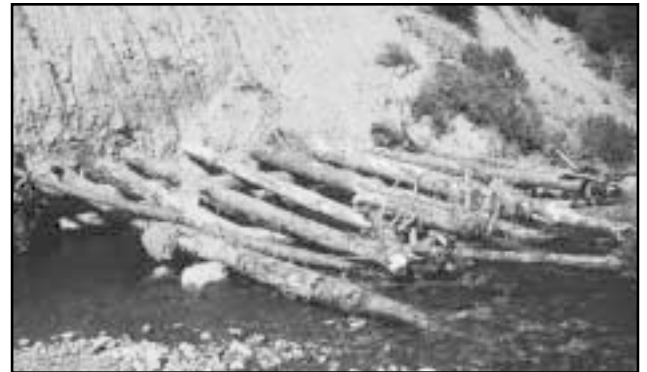
Figure 6. Debris groin located at a large steep eroding bank. Rootwads are used to gain elevation for the wide ramp of logs constructed at Narrowlake Creek.

(Figure 6). Machine-planted willow clumps to a depth that roots are wetted will also accelerate bank recovery.
